SANTA ANA WATERSHED ASSOCIATION ANNUAL REGULATORY REPORT

MITIGATION PROJECTS
JULY 1ST, 2023 – JUNE 30TH, 2024

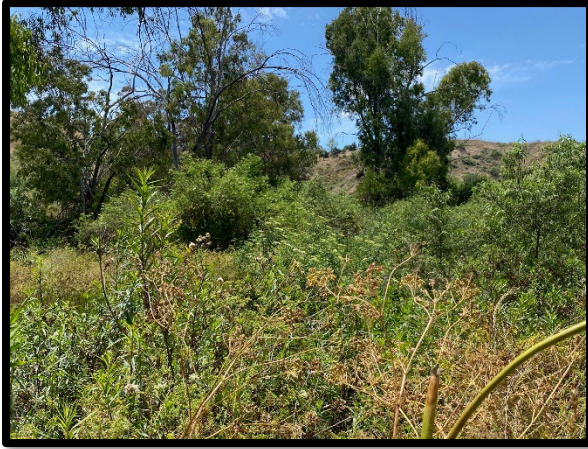
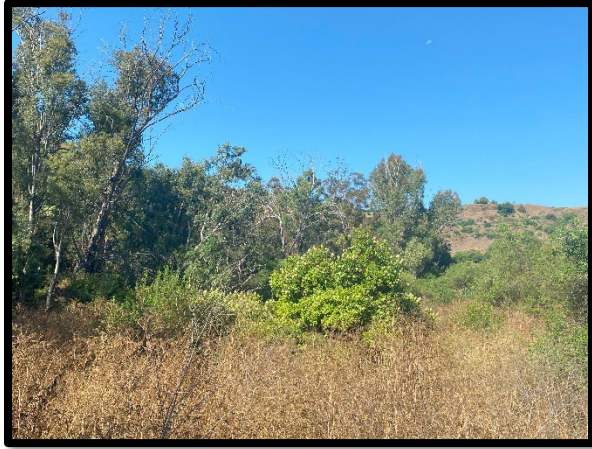
PP#3/3A: PP#3 TAKEN 6/21/23 (LEFT) & PP#3A TAKEN 6/27/24 (RIGHT). PHOTOPOINT #3 WAS SHIFTED FROM ITS ORIGINAL POSITION TO POINT 3A DUE TO VEGETATION OBSCURING VIEW.

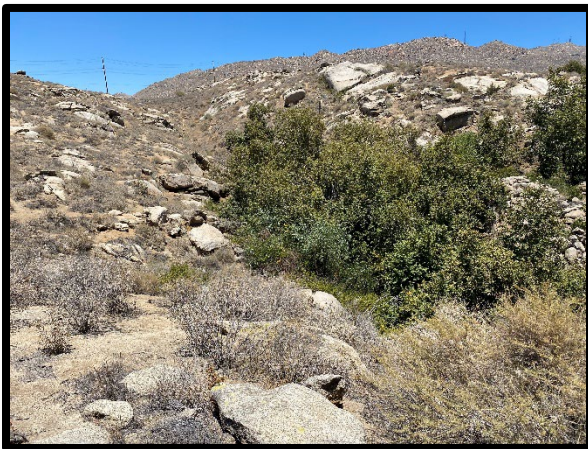
PP#6 TAKEN 6/24/22 (LEFT) AND 6/6/24 (RIGHT). PHOTOPOINT #6 WAS NOT PHOTOGRAPHED IN 2023.

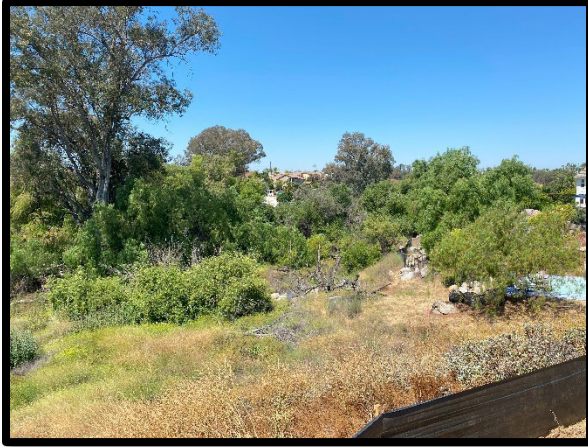
PP#2 TAKEN 6/27/23 (LEFT). DUE TO NEW HOME CONSTRUCTION, PHOTO POINT #2 IS NO LONGER ACCESSIBLE AND WILL NOT BE INCLUDED IN THIS OR SUBSEQUENT REPORTS.

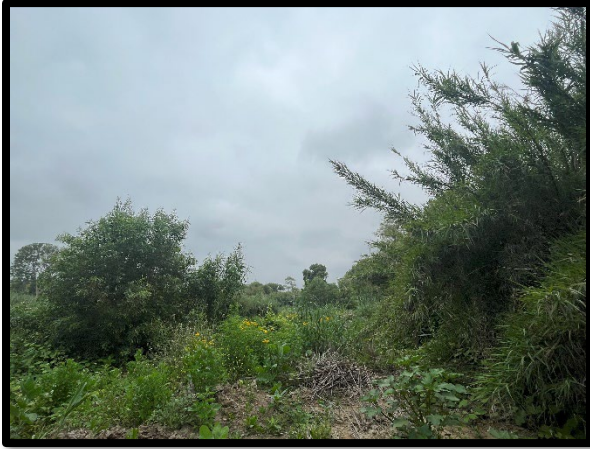
PP#1 TAKEN 6/14/23 (LEFT). PHOTOPOINT #1 WAS OBSCURED BY VEGETATION IN 2024; PHOTO POINTS #7 AND #8, ESTABLISHED IN 2024, SHOW A BROAD VIEW OF THE SITE NEAR THIS LOCATION.

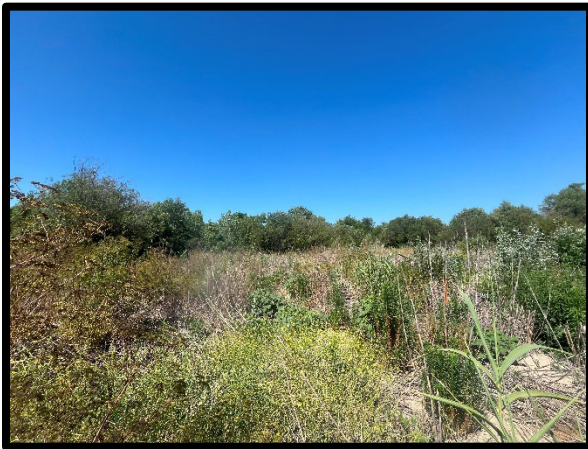
PP#5 ESTABLISHED 6/21/24 TO REPLACE PP#2, AS BROAD VIEW OF THE SITE FORMERLY VISIBLE IN PP #2 IS NOW OBSCURED BY VEGETATION.

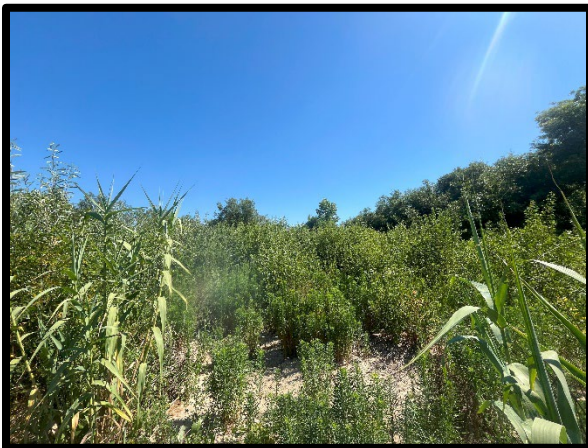
PP#6 ESTABLISHED 6/21/24 TO REPLACE PP#3, AS BROAD VIEW OF THE SITE FORMERLY VISIBLE IN PP #2 IS NOW OBSCURED BY VEGETATION.

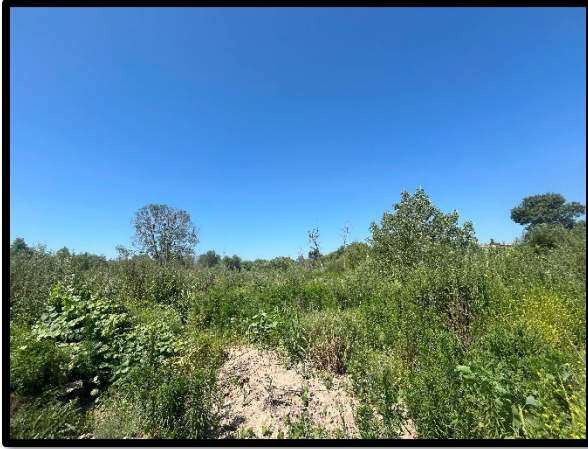
PP#7 ESTABLISHED 6/21/24 TO REPLACE PP#1, AS VIEW OF THE SITE FORMERLY VISIBLE IN PP #1 IS NOW OBSCURED BY VEGETATION.

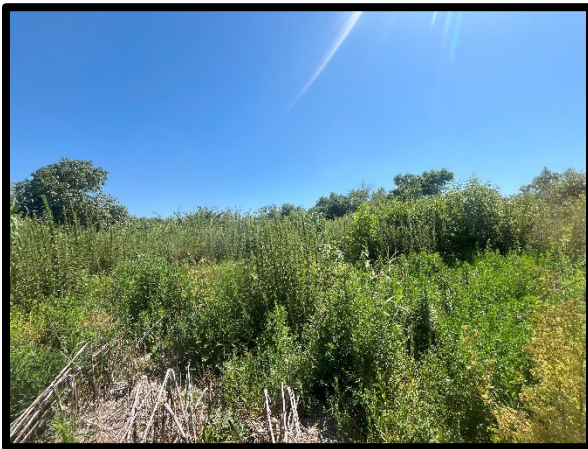
PP#8 ESTABLISHED 6/21/24 TO REPLACE PP#1, AS VIEW OF THE SITE FORMERLY VISIBLE IN PP #1 IS NOW OBSCURED BY VEGETATION.

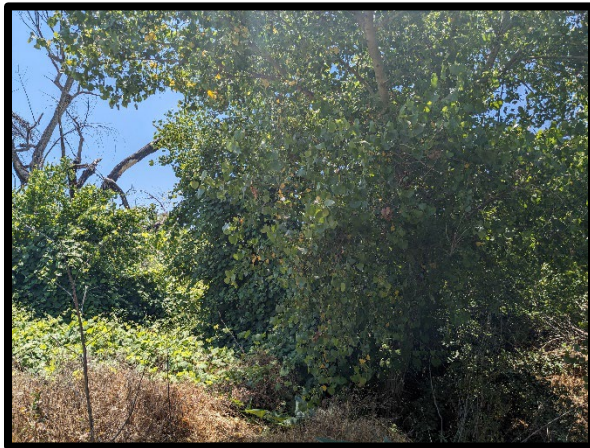
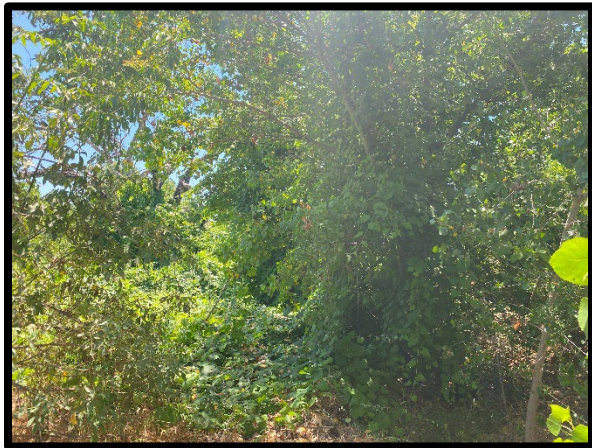
PP#2 TAKEN 6/30/23 (LEFT) AND PP#2A TAKEN 6/20/24 (RIGHT). PP#2 WAS SHIFTED IN 2024 DUE TO SOIL EROSION.

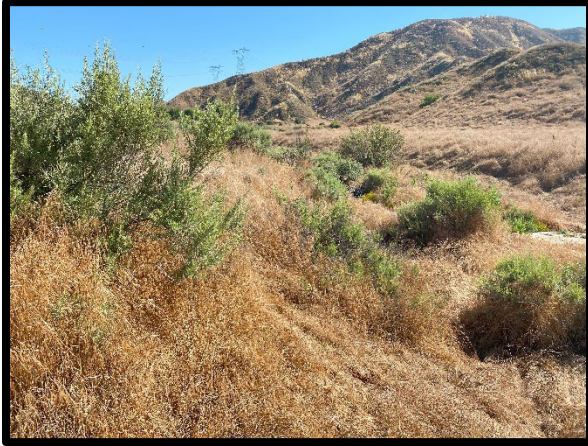
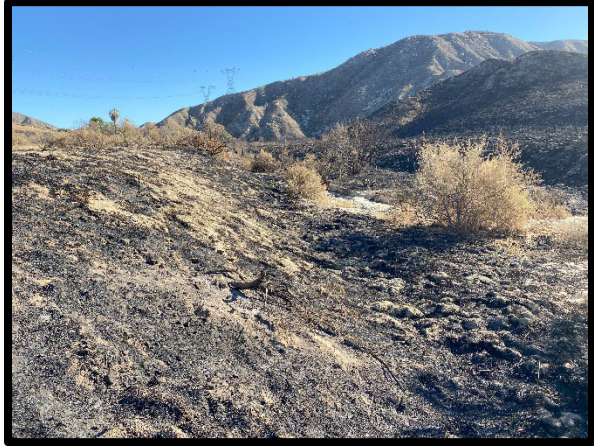
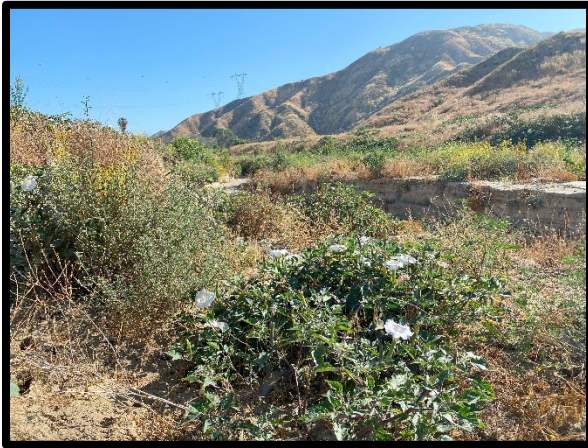
PP#1 TAKEN 6/27/23 (TOP LEFT), 8/7/23 AFTER THE RABBIT FIRE (RIGHT), AND 6/13/24 (BOTTOM LEFT).

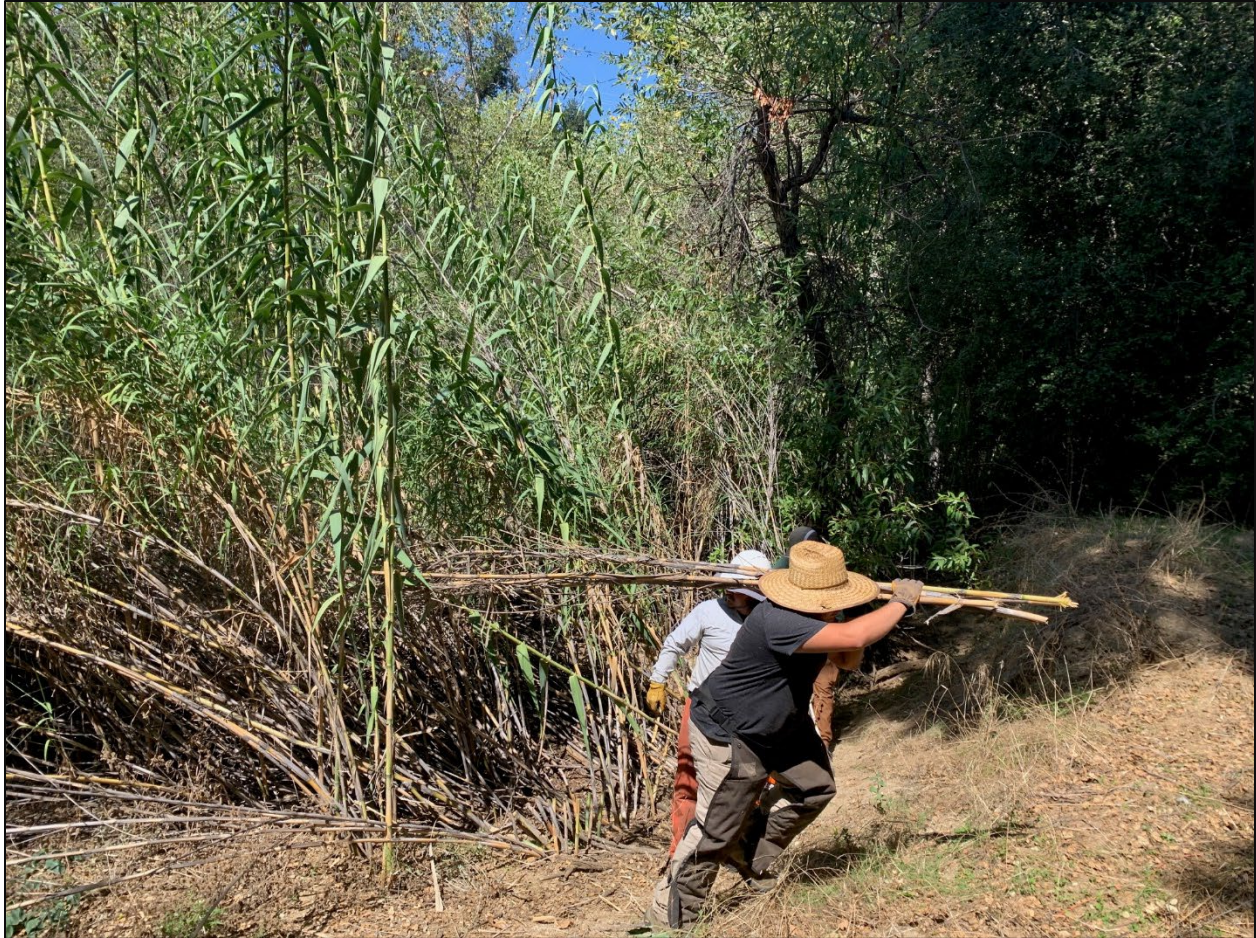
ARUNDO REMOVALS IN LIVE OAK CANYON, FALL 2023

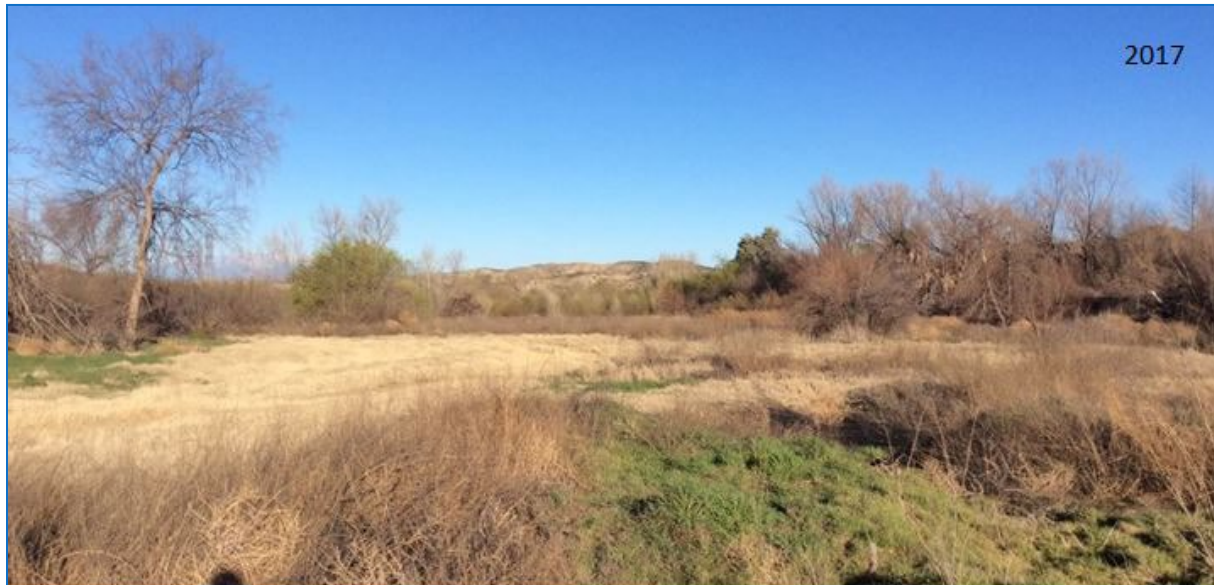
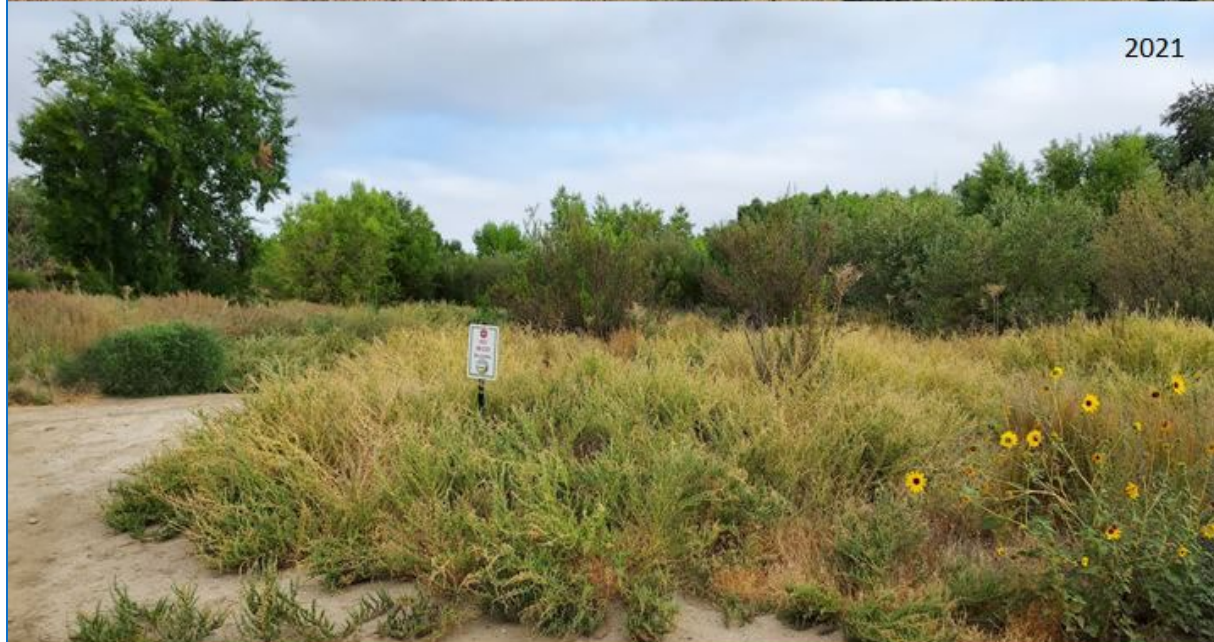
Phase 3 restoration areas outside of alkali meadow planting were passively restored, through intensive invasive species control, with naturally occurring native herbaceous species. Featured are large patches of native saltscare (*Atriplex serenana*), recruited from seed free of invasive competition.

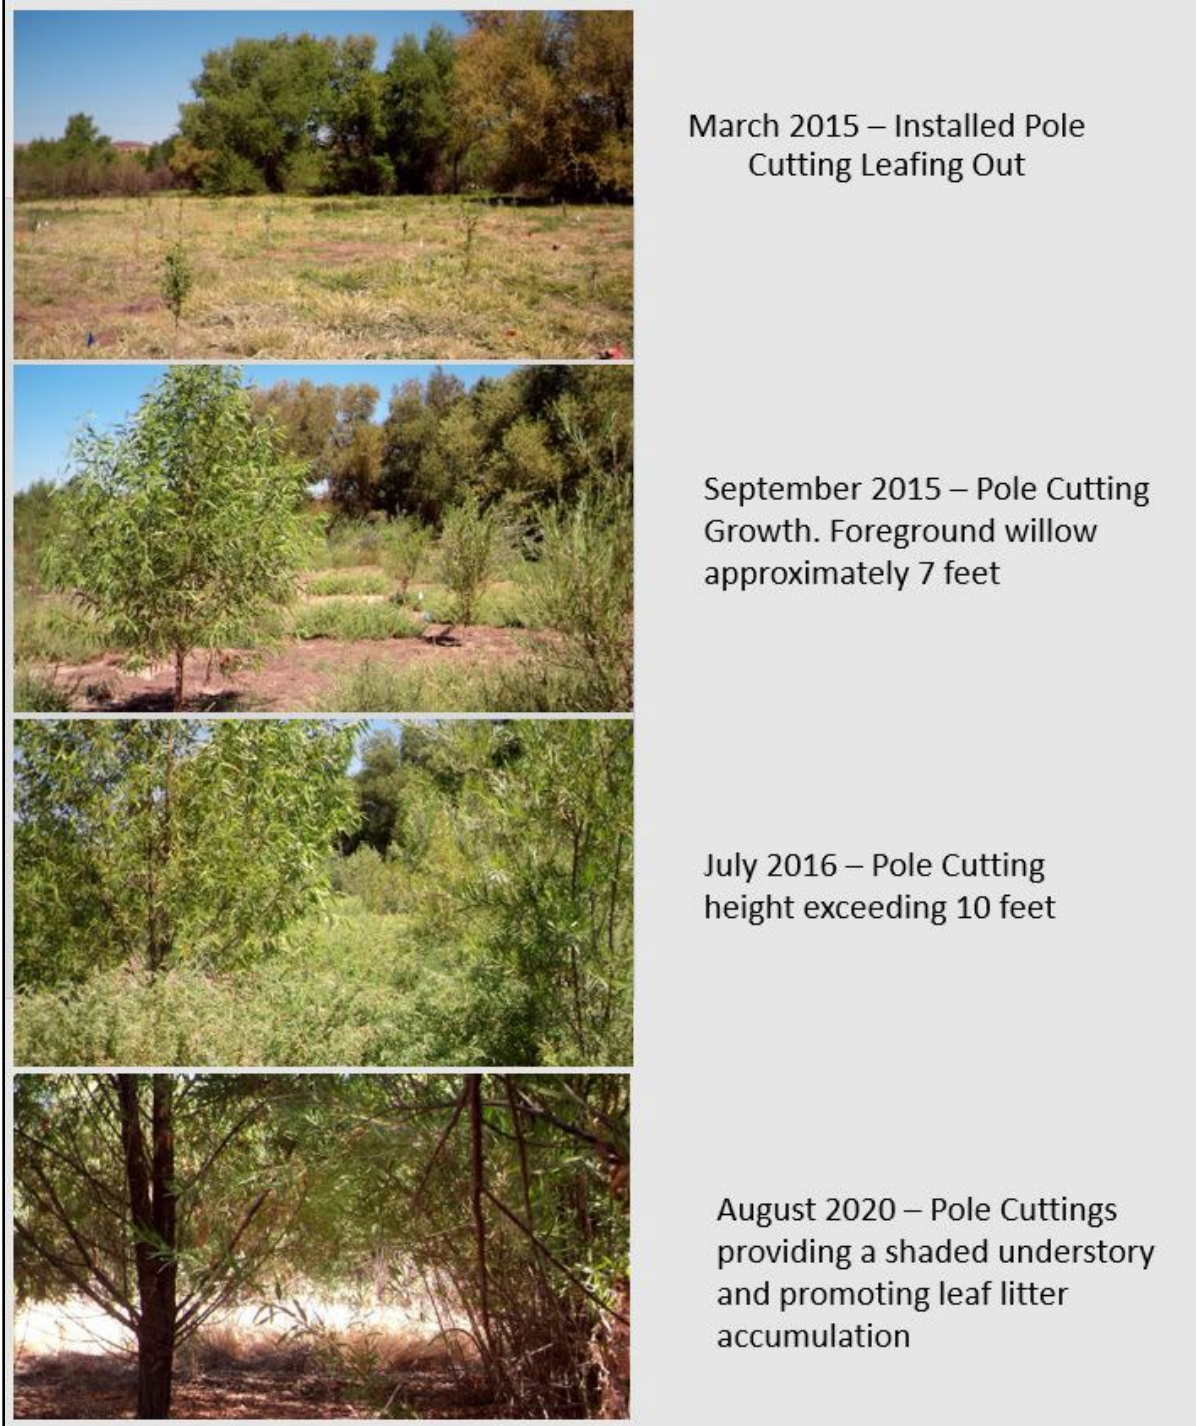
Phase 2 Restoration: Prior to restoration, IERCD staff installed a permanent timelapse camera to document willow growth and restoration success. The four images above show the 5-year progress of the restoration pole cuttings.

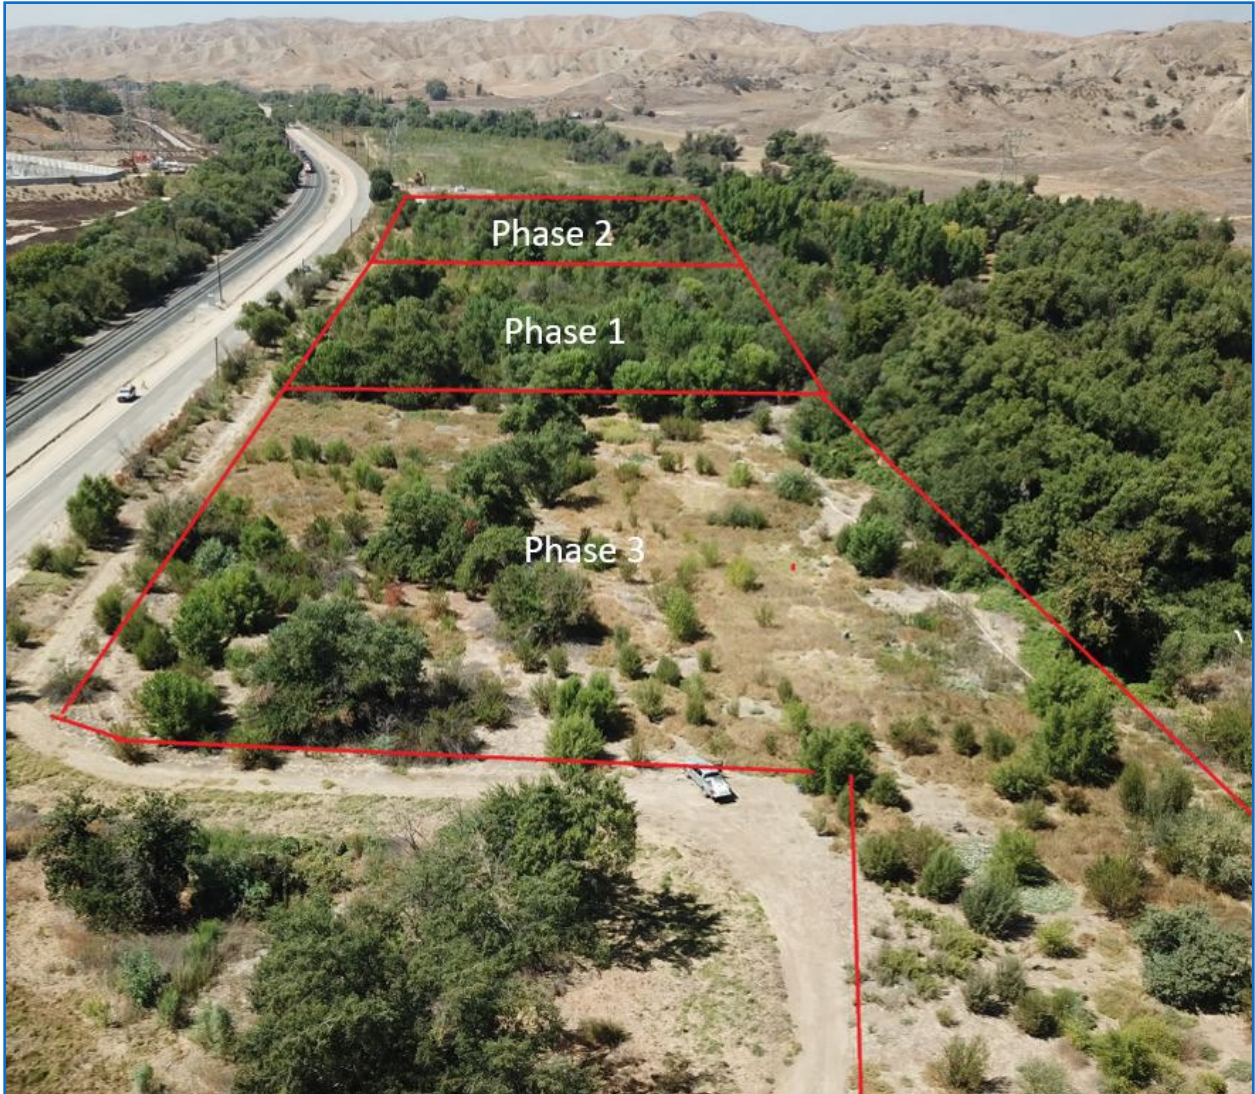
Cienega Restoration Phases: Aerial photo taken in 2018 showing full riparian woodland

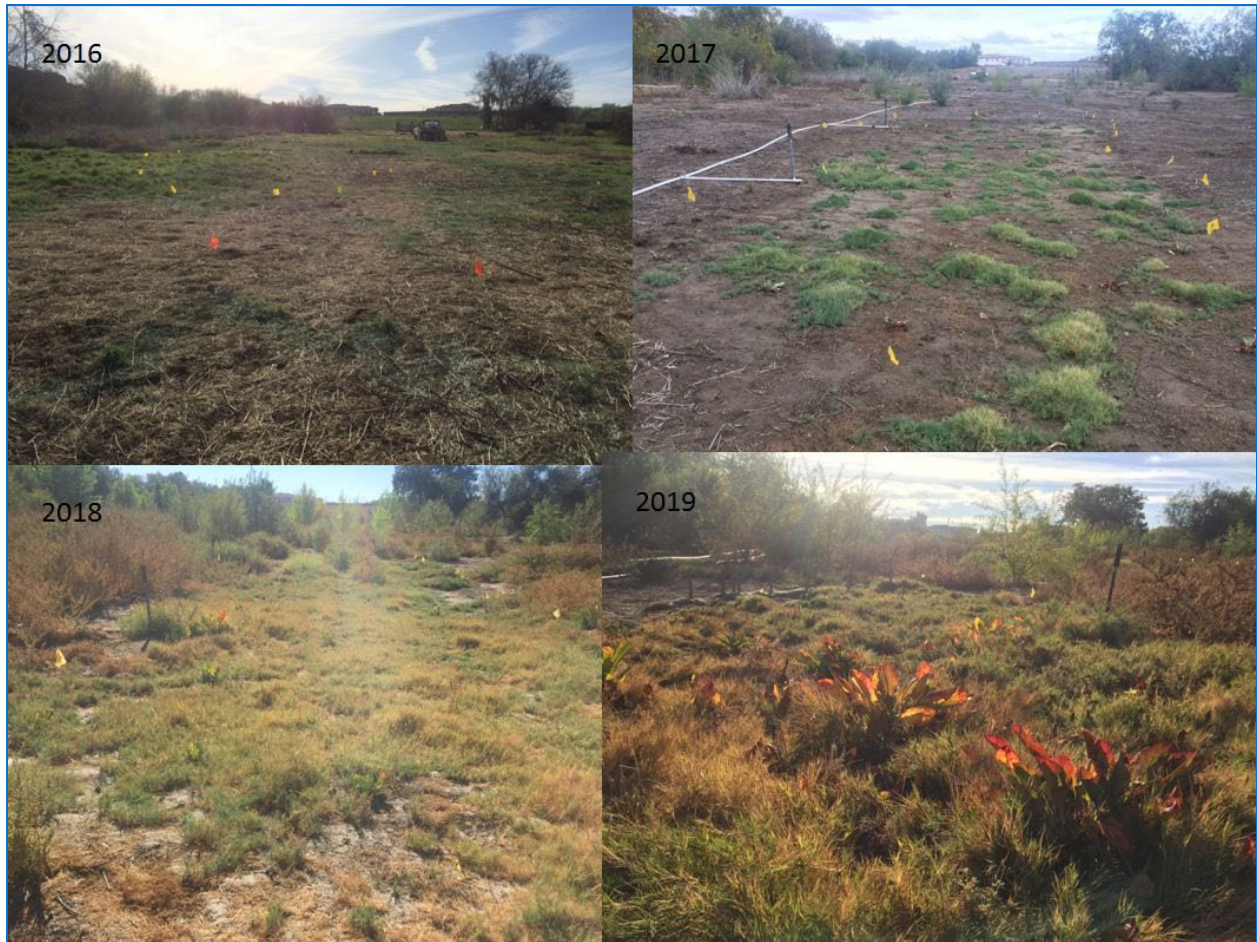
Alkali meadow restoration in depressional areas in the northern part of the phase 3 restoration. Featured species include salt grass (*Distichlis spicata*) and yerba mansa (*Anemopsis californica*).

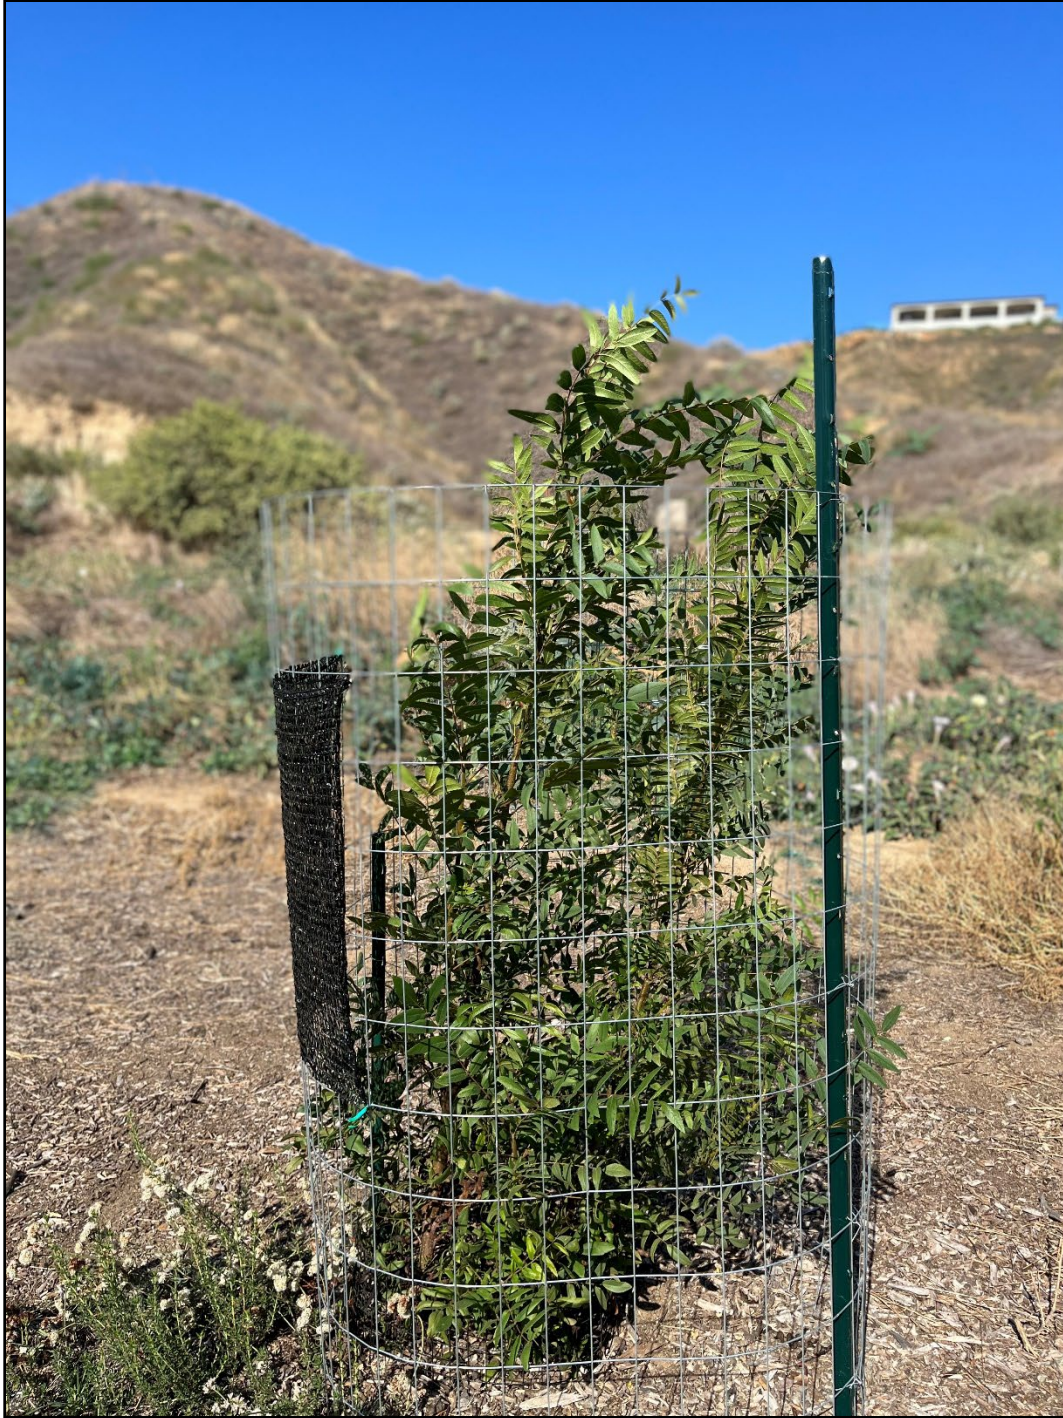
San Timoteo Nature Sanctuary Restoration: Coast live oak/southern California walnut transitional restoration area. Depicted is southern California walnut (*Juglans californica*) three feet in height less than one year after being planted as a seed. October 2023.

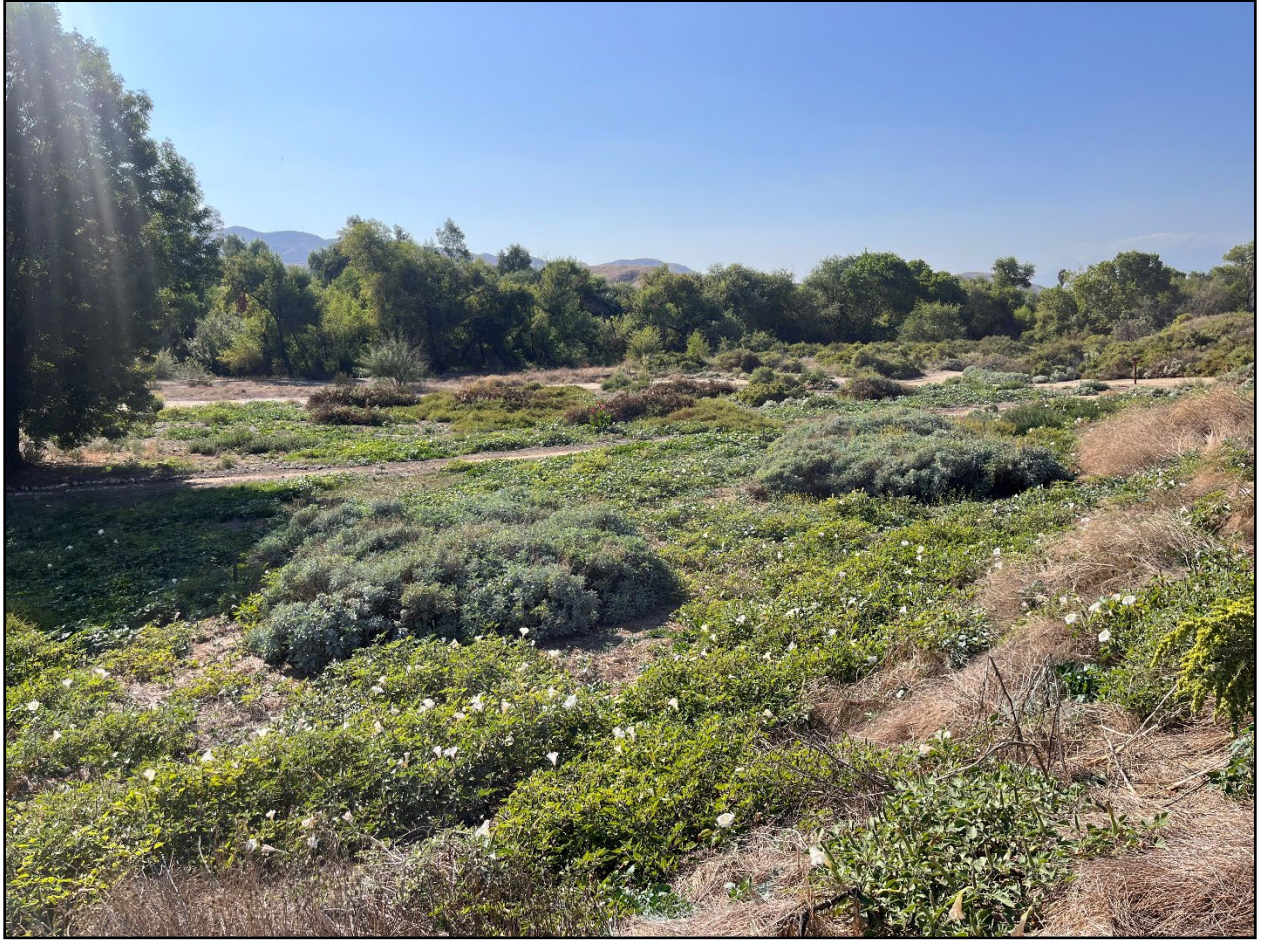
San Timoteo Nature Sanctuary Restoration: Upland buffer restoration consisting of seeded 15'x15' seeded square plots. Due to an exceptional rainy season, brittlebush and buckwheat shrubs established filled in seeded plots over the course of a single year. July 2023.

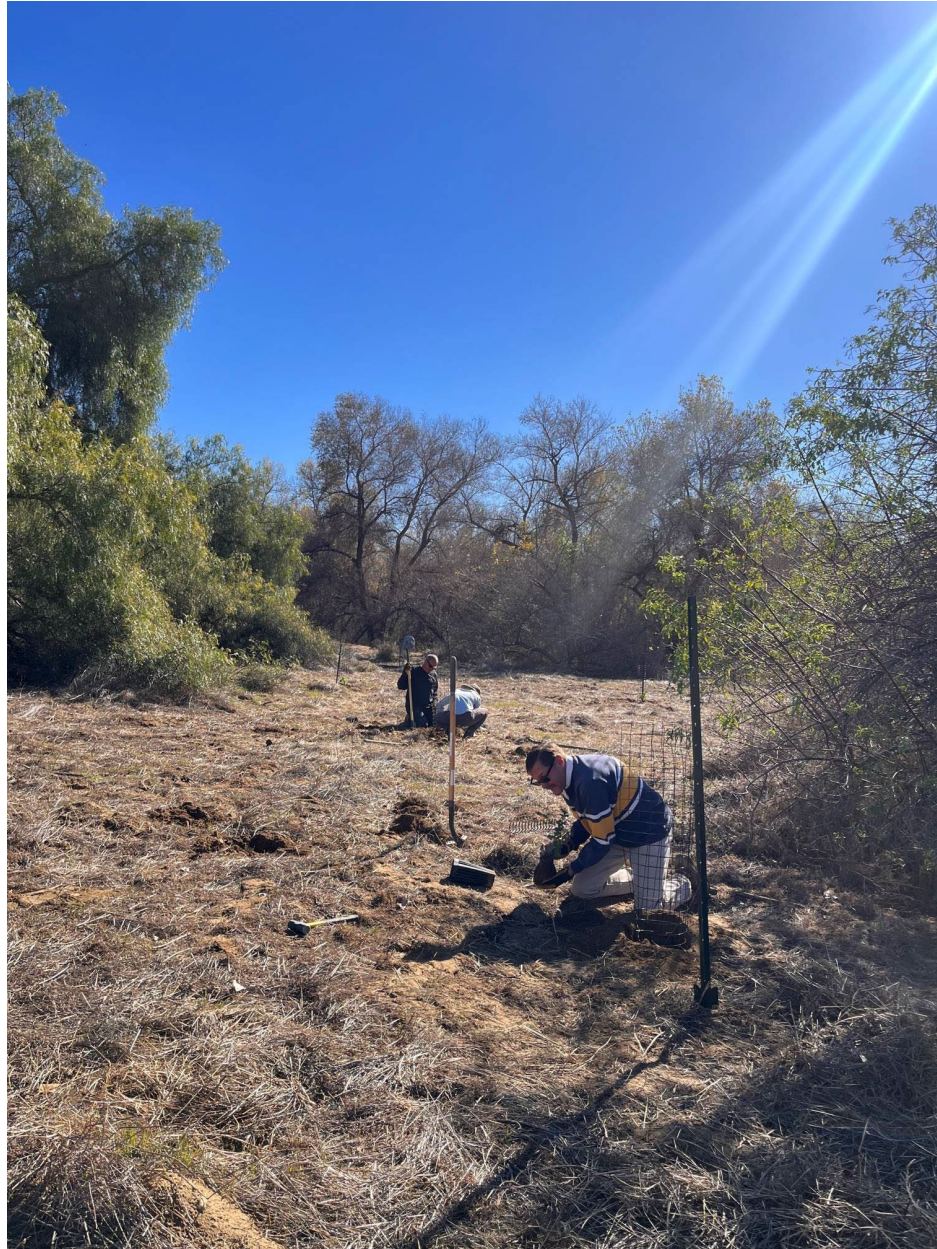
San Timoteo Nature Sanctuary Restoration: Installation of 0.63 acre coast live oak/ walnut woodlands with Redlands Conservancy Volunteers. January 2024.

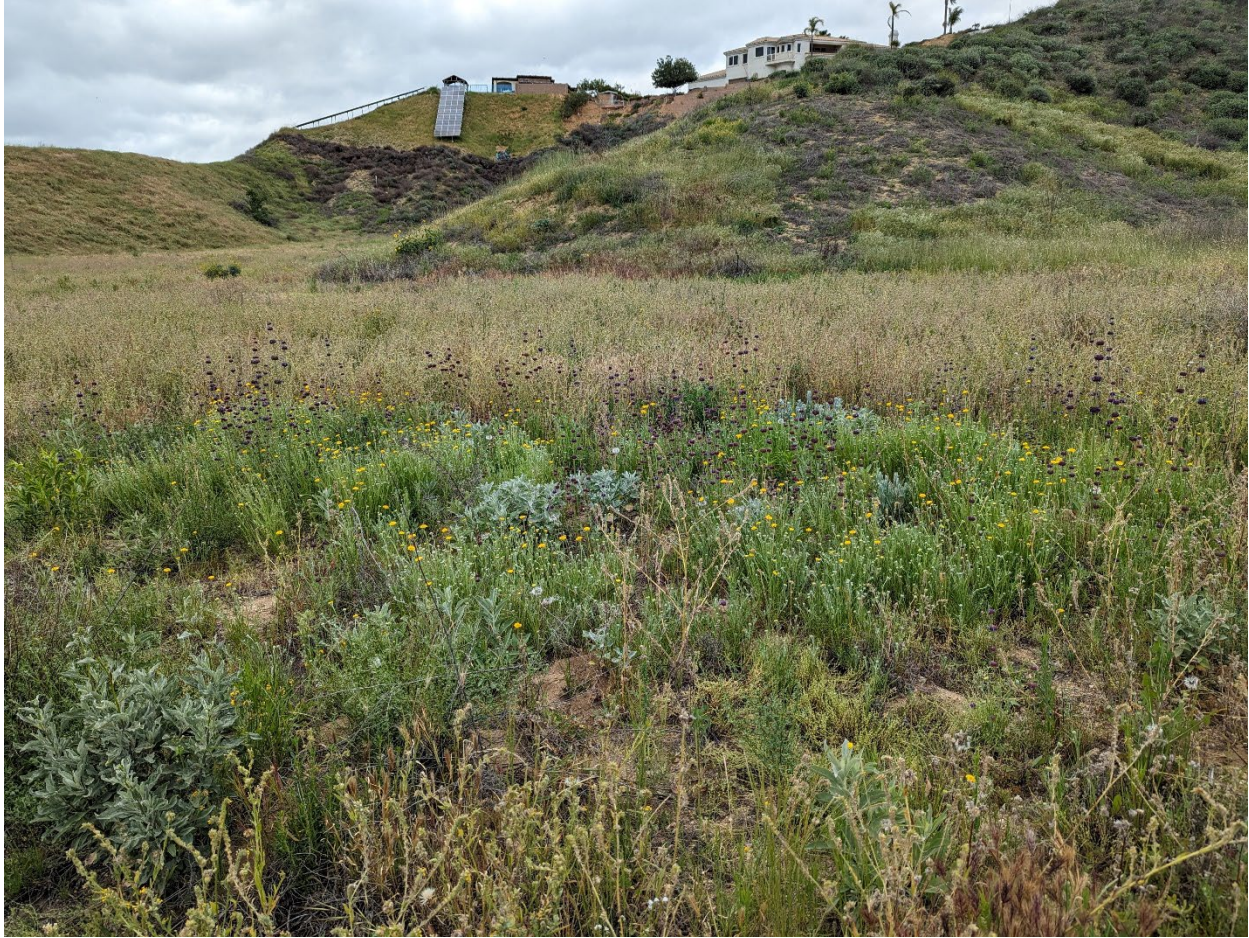
San Timoteo Nature Sanctuary Restoration Native forbs (*Salvia columbariae*, *Chaenactis glabrisculsa*) and brittlebush recruits in CSS restoration plots.
