SANTA ANA WATERSHED ASSOCIATION ANNUAL REGULATORY REPORT

MITIGATION PROJECTS
JULY 1ST 2021 – JUNE 30TH, 2022

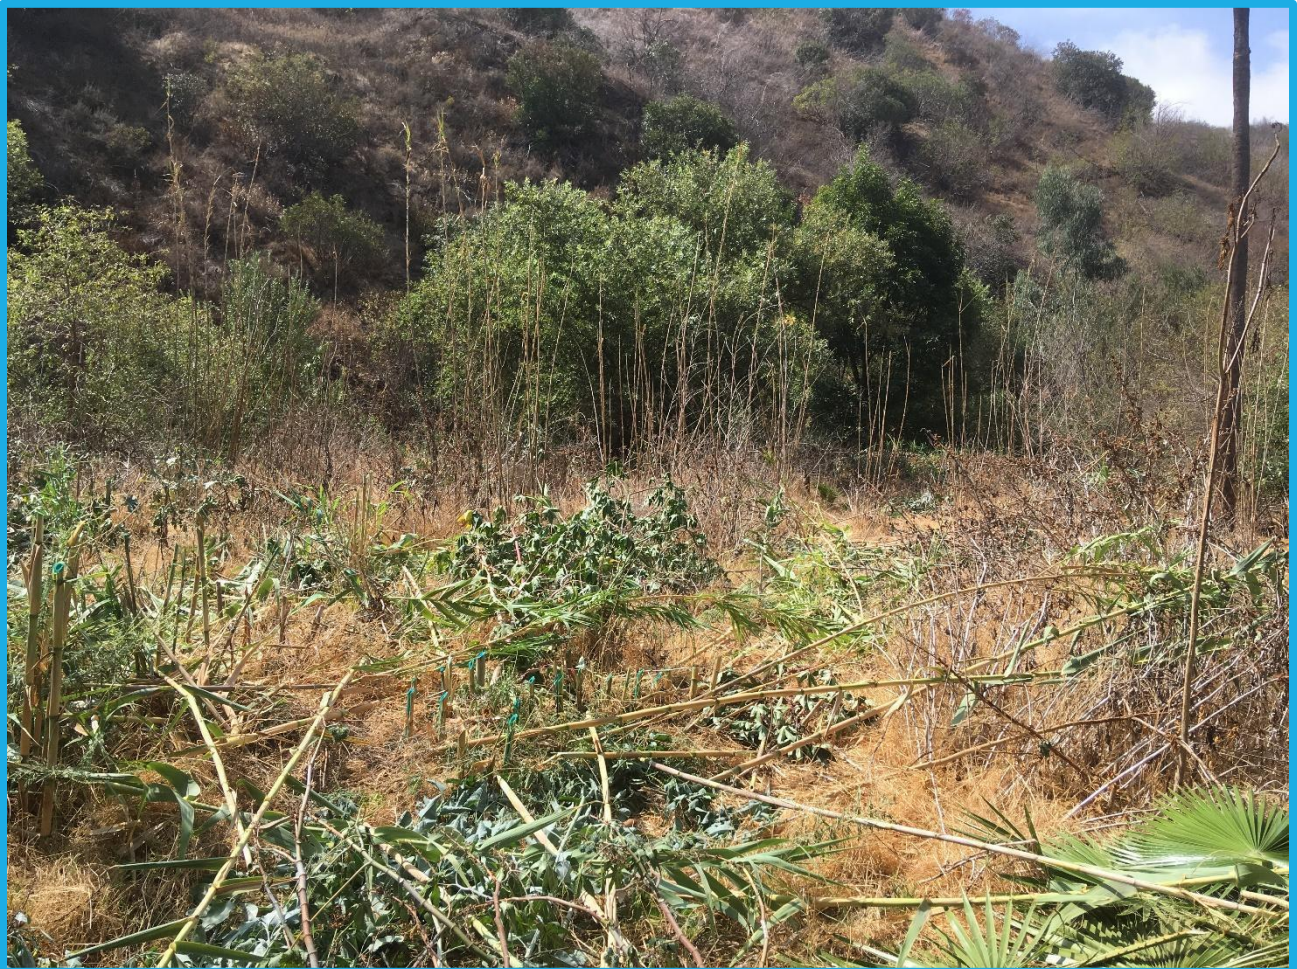
Arundo treatment in Carbon Canyon.

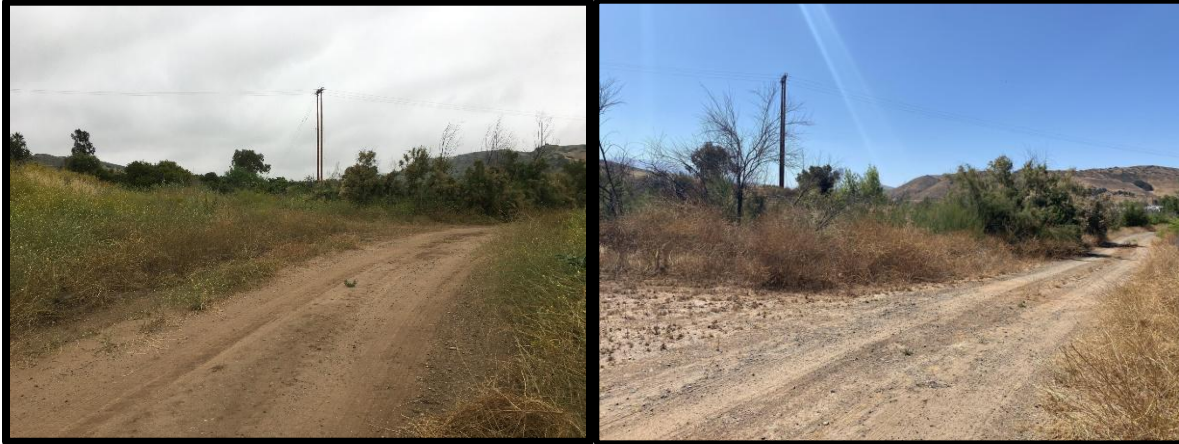
PP#1A TAKEN 6/20/19 (LEFT) AND 7/5/22 (RIGHT).

Table 4: Current Site Conditions		
Average tree height class:	>5-10 meters	
Average shrub height class:	>1-2 meters	
Overall vegetative coverage:	>25-50%	
Common Name	Scientific Name	Coverage Class
Goodding's Black Willow	<i>Salix gooddingii</i>	>15-25%
Mulefat	<i>Baccharis salicifolia</i>	>15-25%
Arroyo Willow	<i>Salix lasiolepis</i>	1-5%
Red Willow	<i>Salix laevigata</i>	Trace
Non-native coverage:	>25-50%

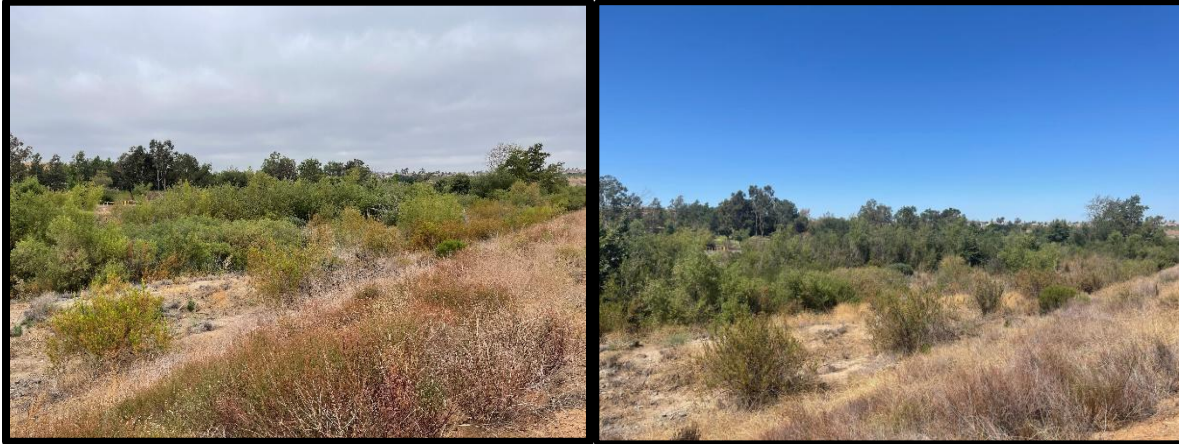
PP#1 TAKEN 6/24/21 (LEFT) AND 6/28/22 (RIGHT).

Table 4: Current Site Conditions		
Average tree height class:	>15-20 meters	
Average shrub height class:	>2-5 meters	
Overall vegetative coverage:	> 50- 75%	
Native coverage:	> 25- 50%	
Common Name	Scientific Name	Coverage Class
Mulefat	<i>Baccharis salicifolia</i>	>5-15%

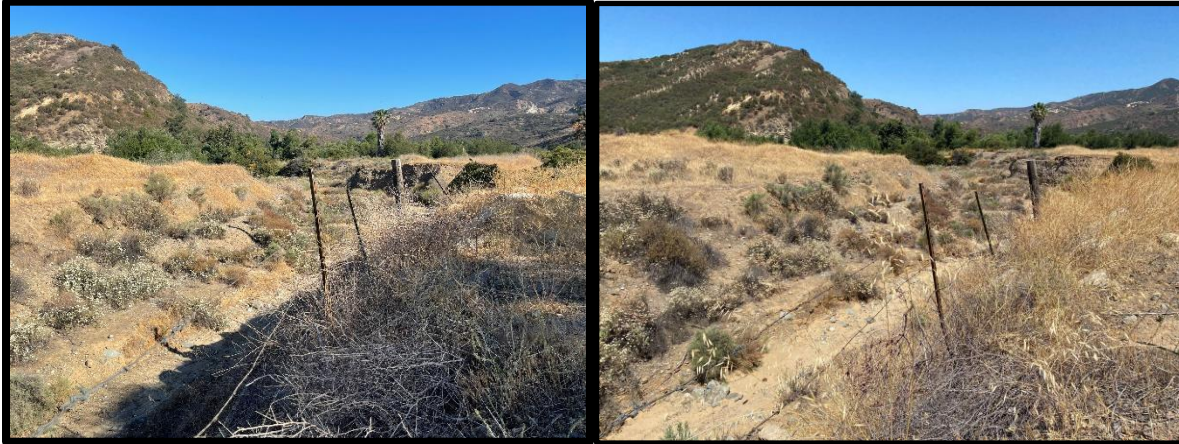
PP#4 TAKEN 6/25/21 (LEFT) AND 6/29/22 (RIGHT).

Table 4: Current Site Conditions		
Average tree height class:		>15-20 meters
Average shrub height class:		>2-5 meters
Overall vegetative coverage:		>50-75%
Native coverage:		>50-75%
Common Name	Scientific Name	Coverage Class
Mulefat	<i>Baccharis salicifolia</i>	>5-15%

The Santiago Phase I Project is in its 11th year since project management was given to SAWA. The project goal for this ILF placement is to reduce targeted non-natives (tamarisk, castor bean, and giant reed) to <1%. Within the scope of requirements for SAWA's In-lieu Fee program, the project goal has not been met. Currently giant reed is <1%, castor bean is 1-5%, and tamarisk is absent. Additional removal of giant reed will be required. Other non-native species, such as thistles and mustard, have emerged. Removal of these other non-native species is recommended to preserve habitat quality.

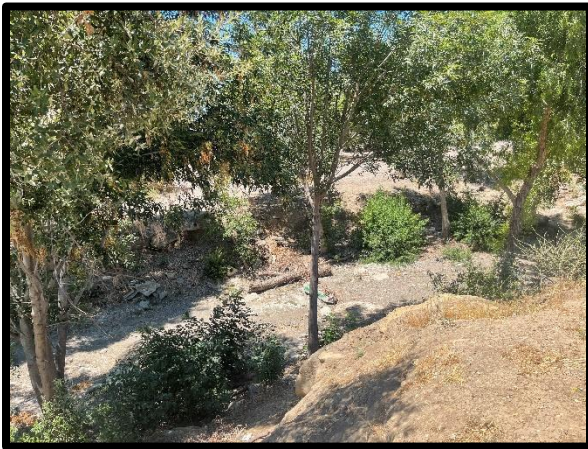
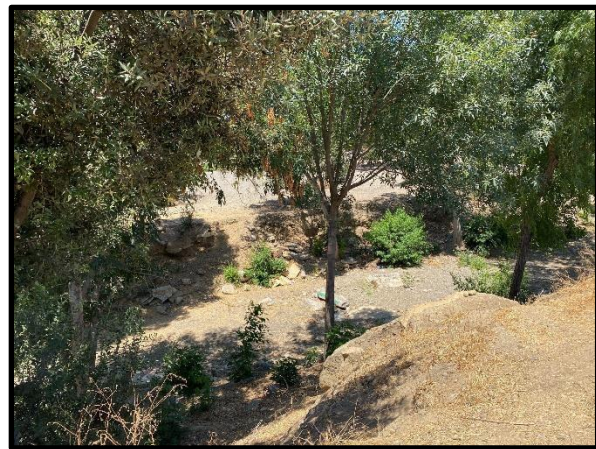
PP#1 TAKEN 6/25/21 (LEFT) AND 6/29/22 (RIGHT).

Table 4: Current Site Conditions		
Average tree height class:		>15-20 meters
Average shrub height class:		>1-2 meters
Overall vegetative coverage:		>25-50%
Native coverage:		>25-50%
Common Name	Scientific Name	Coverage Class
Laurel Sumac	<i>Malosma laurina</i>	5-15%
Prickly Pear	<i>Opuntia sp.</i>	1-5%
California Sagebrush	<i>Artemisia californica</i>	1-5%
Yerba Santa	<i>Eriodictyon californicum</i>	1-5%
California Buckwheat	<i>Eriogonum fasciculatum</i>	1-5%
Gooding's Black Willow	<i>Salix gooddingii</i>	1-5%
Arroyo Willow	<i>Salix lasiolepis</i>	1-5%
Non-native coverage:		>15-25%
Common Name	Scientific Name	Coverage Class
Peruvian Pepper Tree	<i>Schinus molle</i>	>5-15%
Mustard	<i>Brassicaceae sp.</i>	1-5%
Eucalyptus	<i>Eucalyptus sp.</i>	1-5%
Ornamental trees	n/a	1-5%
Fig	<i>Ficus carica</i>	1-5%

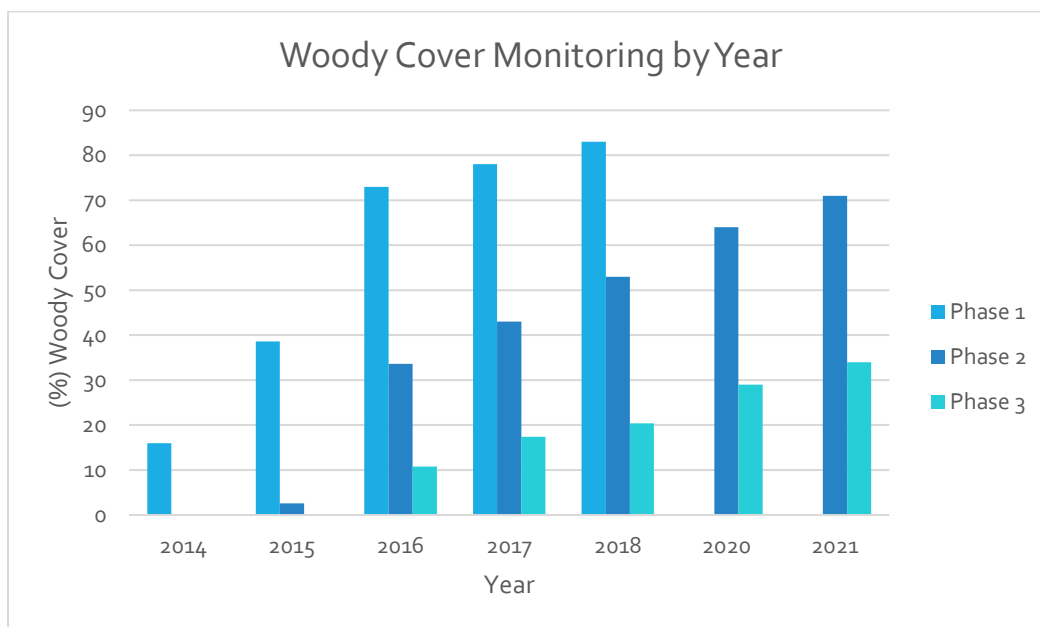
Overall Woody Cover by Phase and Year

2014	2015	2016	2017	2018	2020	2021
Phase 1	16	38.6	73	78	83	-	-
Phase 2	0	2.6	33.6	43	53	64	71
Phase 3	0	0	10.8	17.4	20.4	29	34

*Phase 3 restoration focused on establishment of alkali meadow habitat and less woody cover. Large swaths of the phase 3 site are dominated by low growing native herbaceous species including *Disticlis spicata*, *Spargularia marina*, and *Atriplex serranana*.

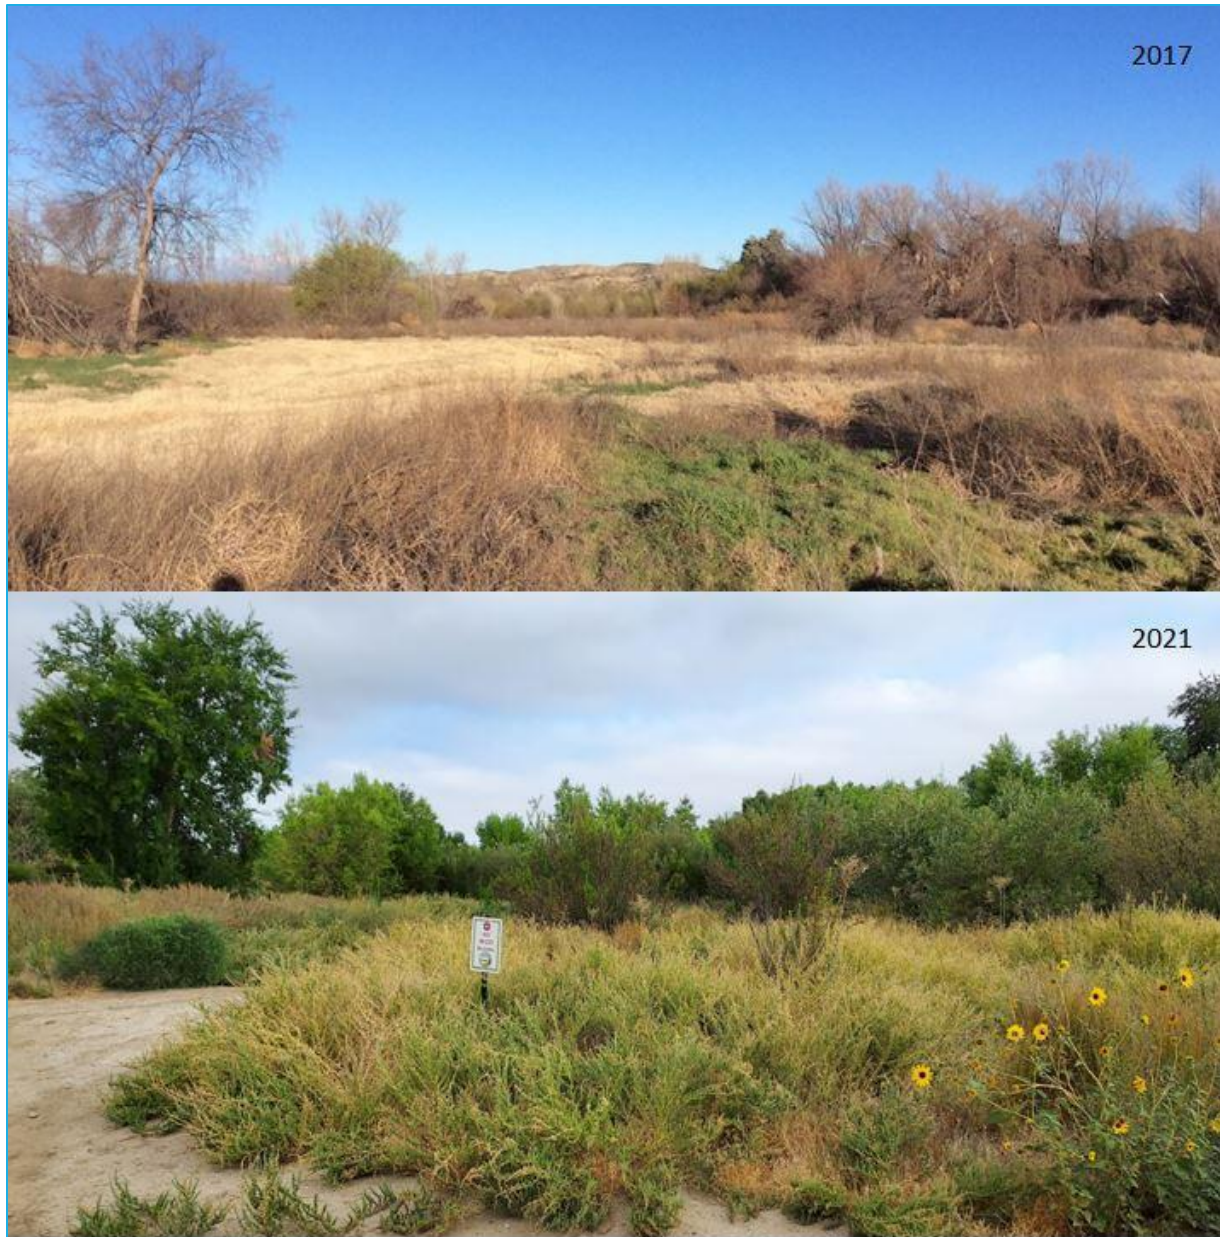
Phase 3 restoration areas outside of alkali meadow planting were passively restored, through intensive invasive species control, with naturally occurring native herbaceous species. Featured are large patches of native saltscale (*Atriplex serenana*), recruited from seed free of invasive competition.

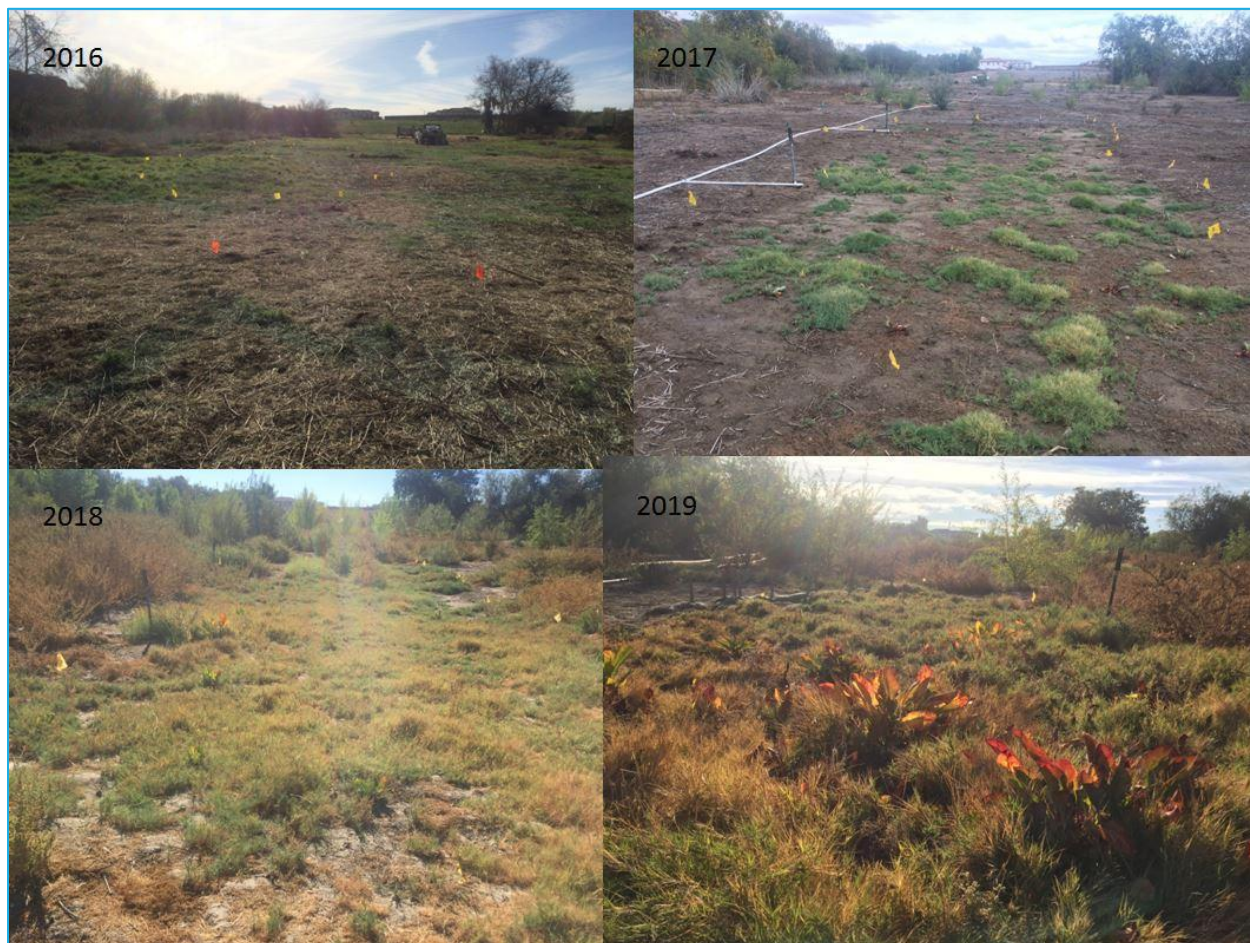
Alkali meadow restoration in depressional areas in the northern part of the phase 3 restoration. Featured species include *Disticlis spicata* and *Anemopsis californica*.
